MEMORANDUM

DATE:	March 28 th , 2016
FROM:	Eric Lancaster
SUBJECT:	March Weekly Progress Report @ Gold King
TO:	Steven Way

Project: Gold King Interim Water Treatment Plant (IWTP)
Location: Gladstone, Colorado
Prepared for: Emergency Response Unit – US EPA Region 8

Reporting Period: Mar 21 – Mar 28
Report No.: 14

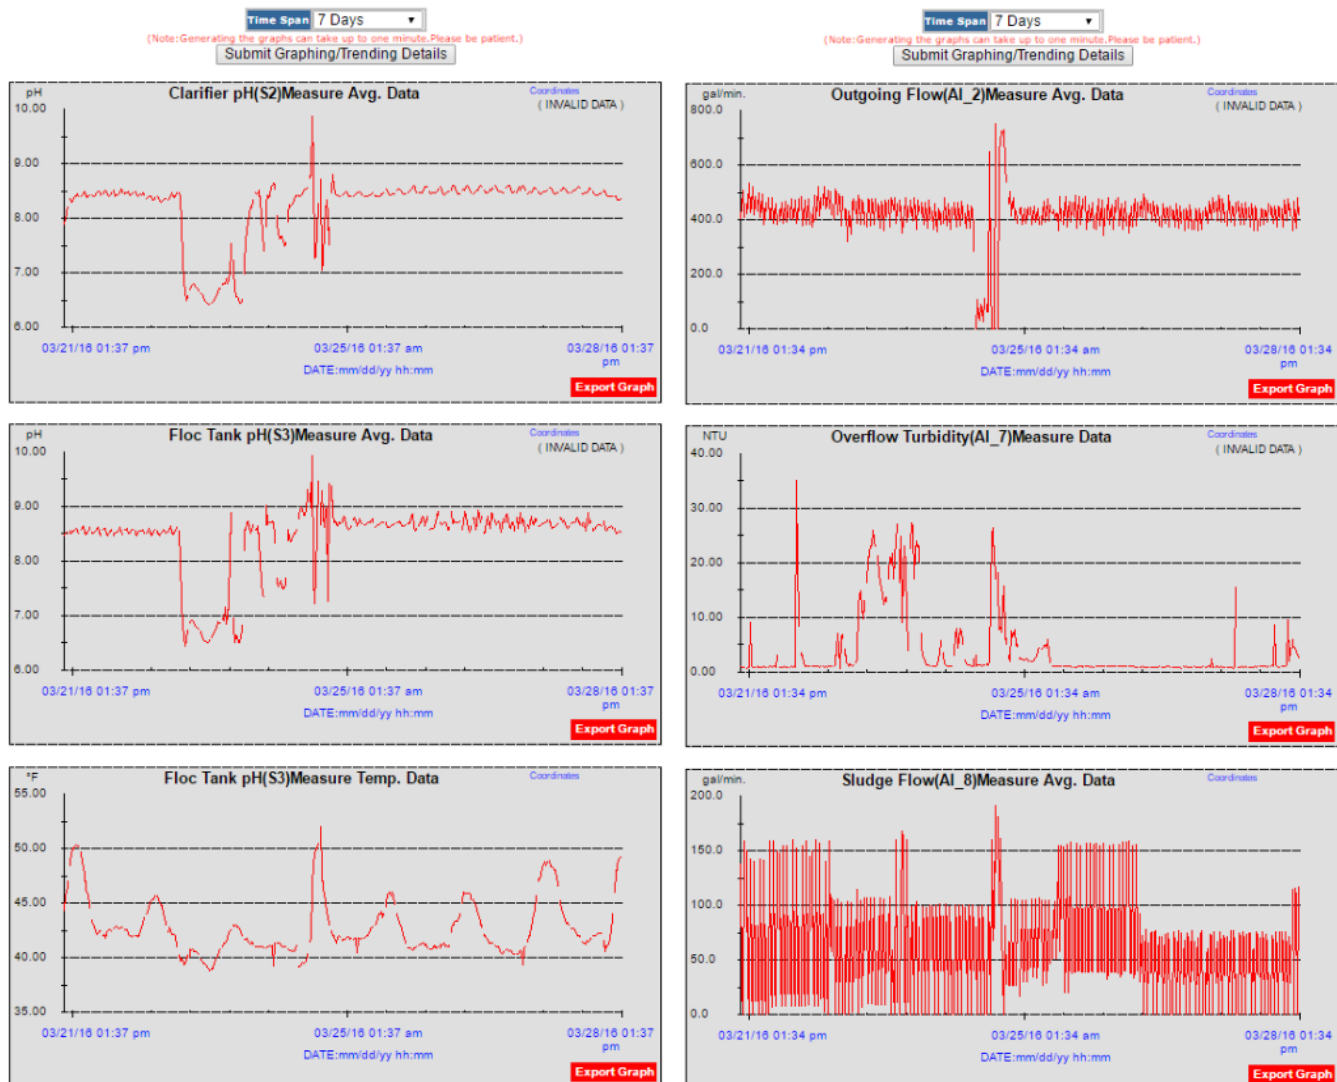
- The following graphs provide trending information collected by datalogging equipment during the previous 7 days. These dataloggers collect control information from the Lime Circuit (left) and Flow Circuit (right) Programmable Logic Controllers (PLCs) at the Gold King IWTP. Over the reporting period (3/21/16 – 3/28/16 inclusive) Alexco treated 4.21 million gallons at an average flow rate of 418 gpm with all discharged treated water leaving the 12" HDPE pipeline.

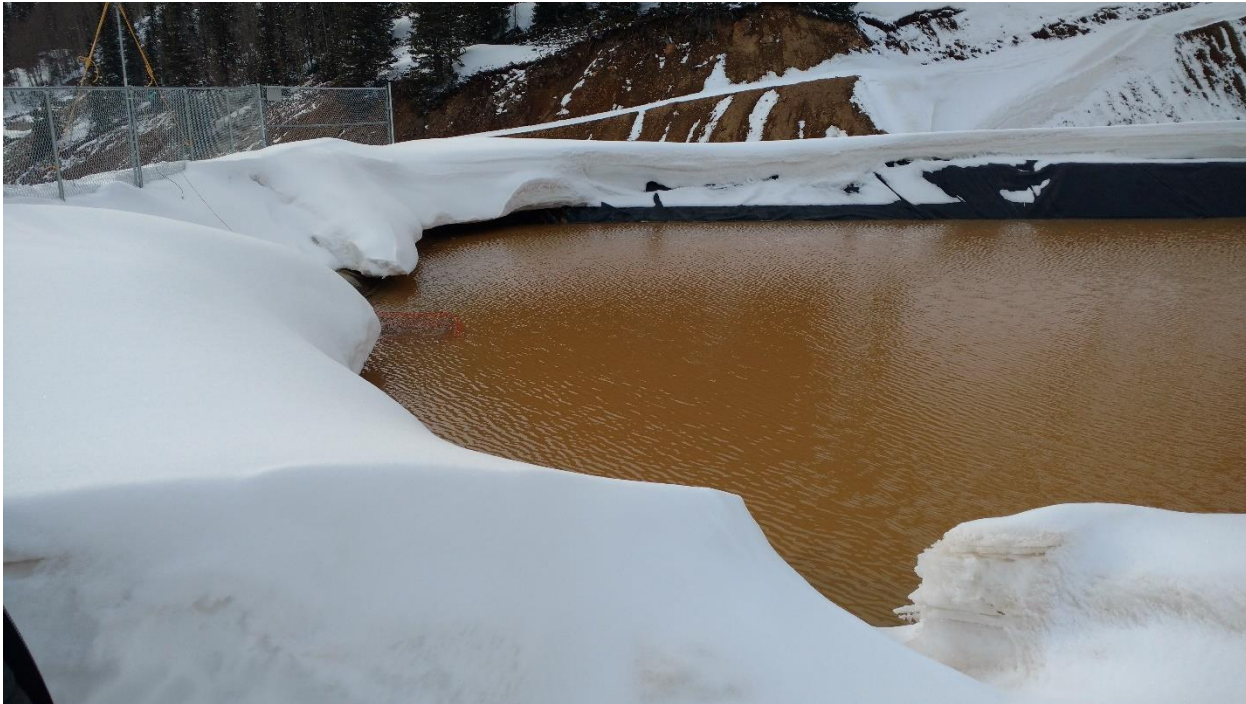
- On 3/24/2016, Alexco shut-down the intakes to the IWTP and backed-up water in Pond 2. Water was then released at increasing flow rates to test the outgoing flow meter, inspect the lime addition system, and monitor turbidity. During this testing, the outgoing flow meter performed well up to 950 gpm, at which time it is unable to monitor increasing flow rates due to entrained air. 2" and 3" HDPE saddles will be installed in the near future to release the entrained air on the discharge side, and allow for the installation of the incoming flow meter immediately upstream of the clarifier.

Figure 1: Pond 2 levels rising during plant shut-down – Taken on 3/28/2016.
